Manhole Inspection Summary

Manhole # S33UU_012MH

Insp Date: **4/13/07 9:29 AM**

Location Address: **117 29TH ST**

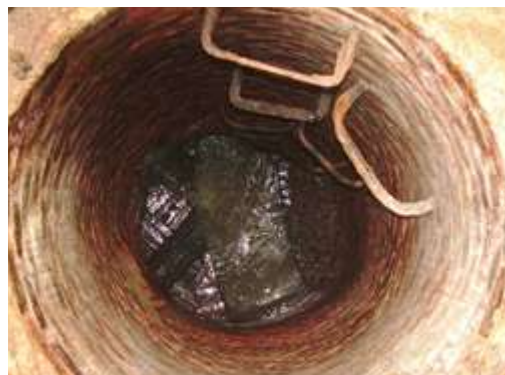
Top View

☐ Parged ☒ **Debris** (not Condition related)

Count: **11** Missing: **0** ☒ **Corroded**

Corroded steps. Bench debris.

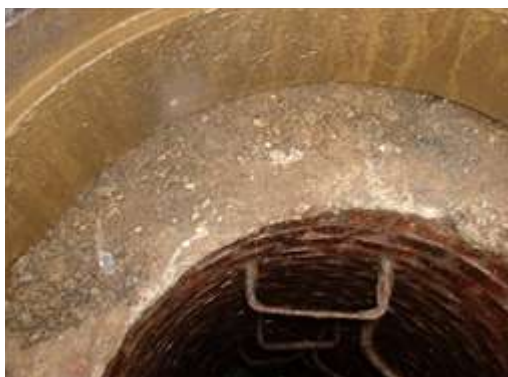
Defect

Frame leaks. Frame offset. Adjustment deterioration and infiltration. Barrel infiltration - other side.

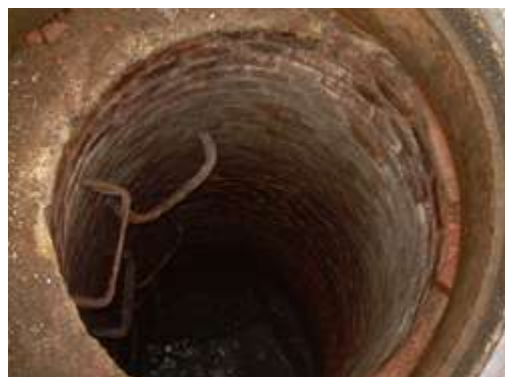
Defect

Frame leaks. Frame offset. Adjustment and Barrel infiltration - other side.

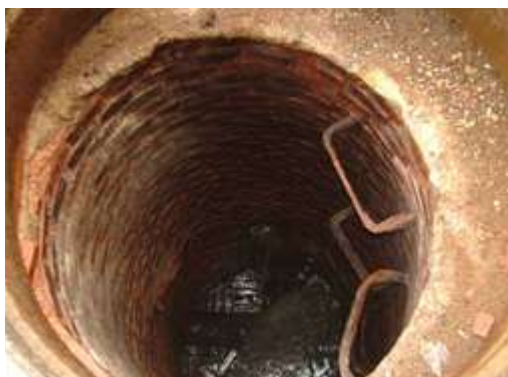
Defect

Frame leaks. Frame offset. Adjustment and Barrel infiltration.

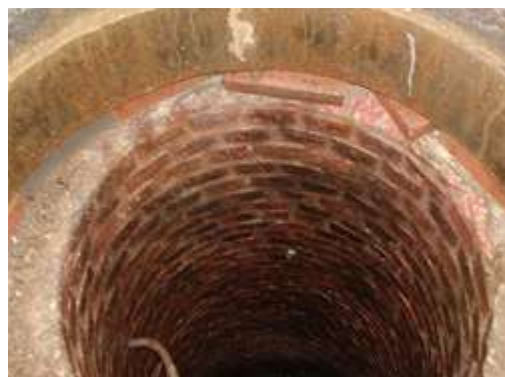
Defect

Condition: ☐ Sound ☐ Cracked ☐ Root Intrusion ☒ **Loose Brick** ☒ **Deteriorated**

Frame leaks. Frame offset. Adjustment deterioration, loose brick and infiltration. Barrel infiltration.

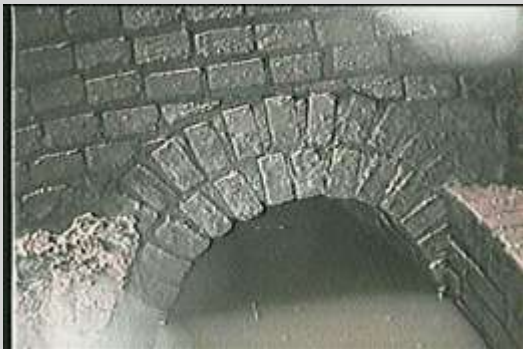
21 in. Circular Gravity Sewer Pipe In @ 6 O'Clock

Barrel deterioration and infiltration.

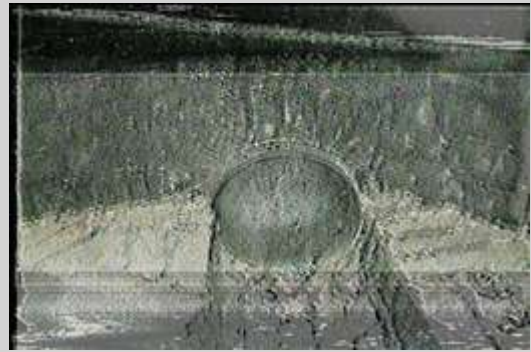
Drop In @ 8 O'Clock

Drop: **Outside** Rod and Bar
Angled: **Yes** Reading: **15.28** (ft.)
Inv Depth: **16.28** (ft.)
Drop Condition: **Clogged**
